MANUAL ON CONSERVATION AND RESTORATION OF MONUMENTS

Proceedings of an Administrator turned
Conservation Archaeologist cum Museologist

DR. R. K. SINGH

2007

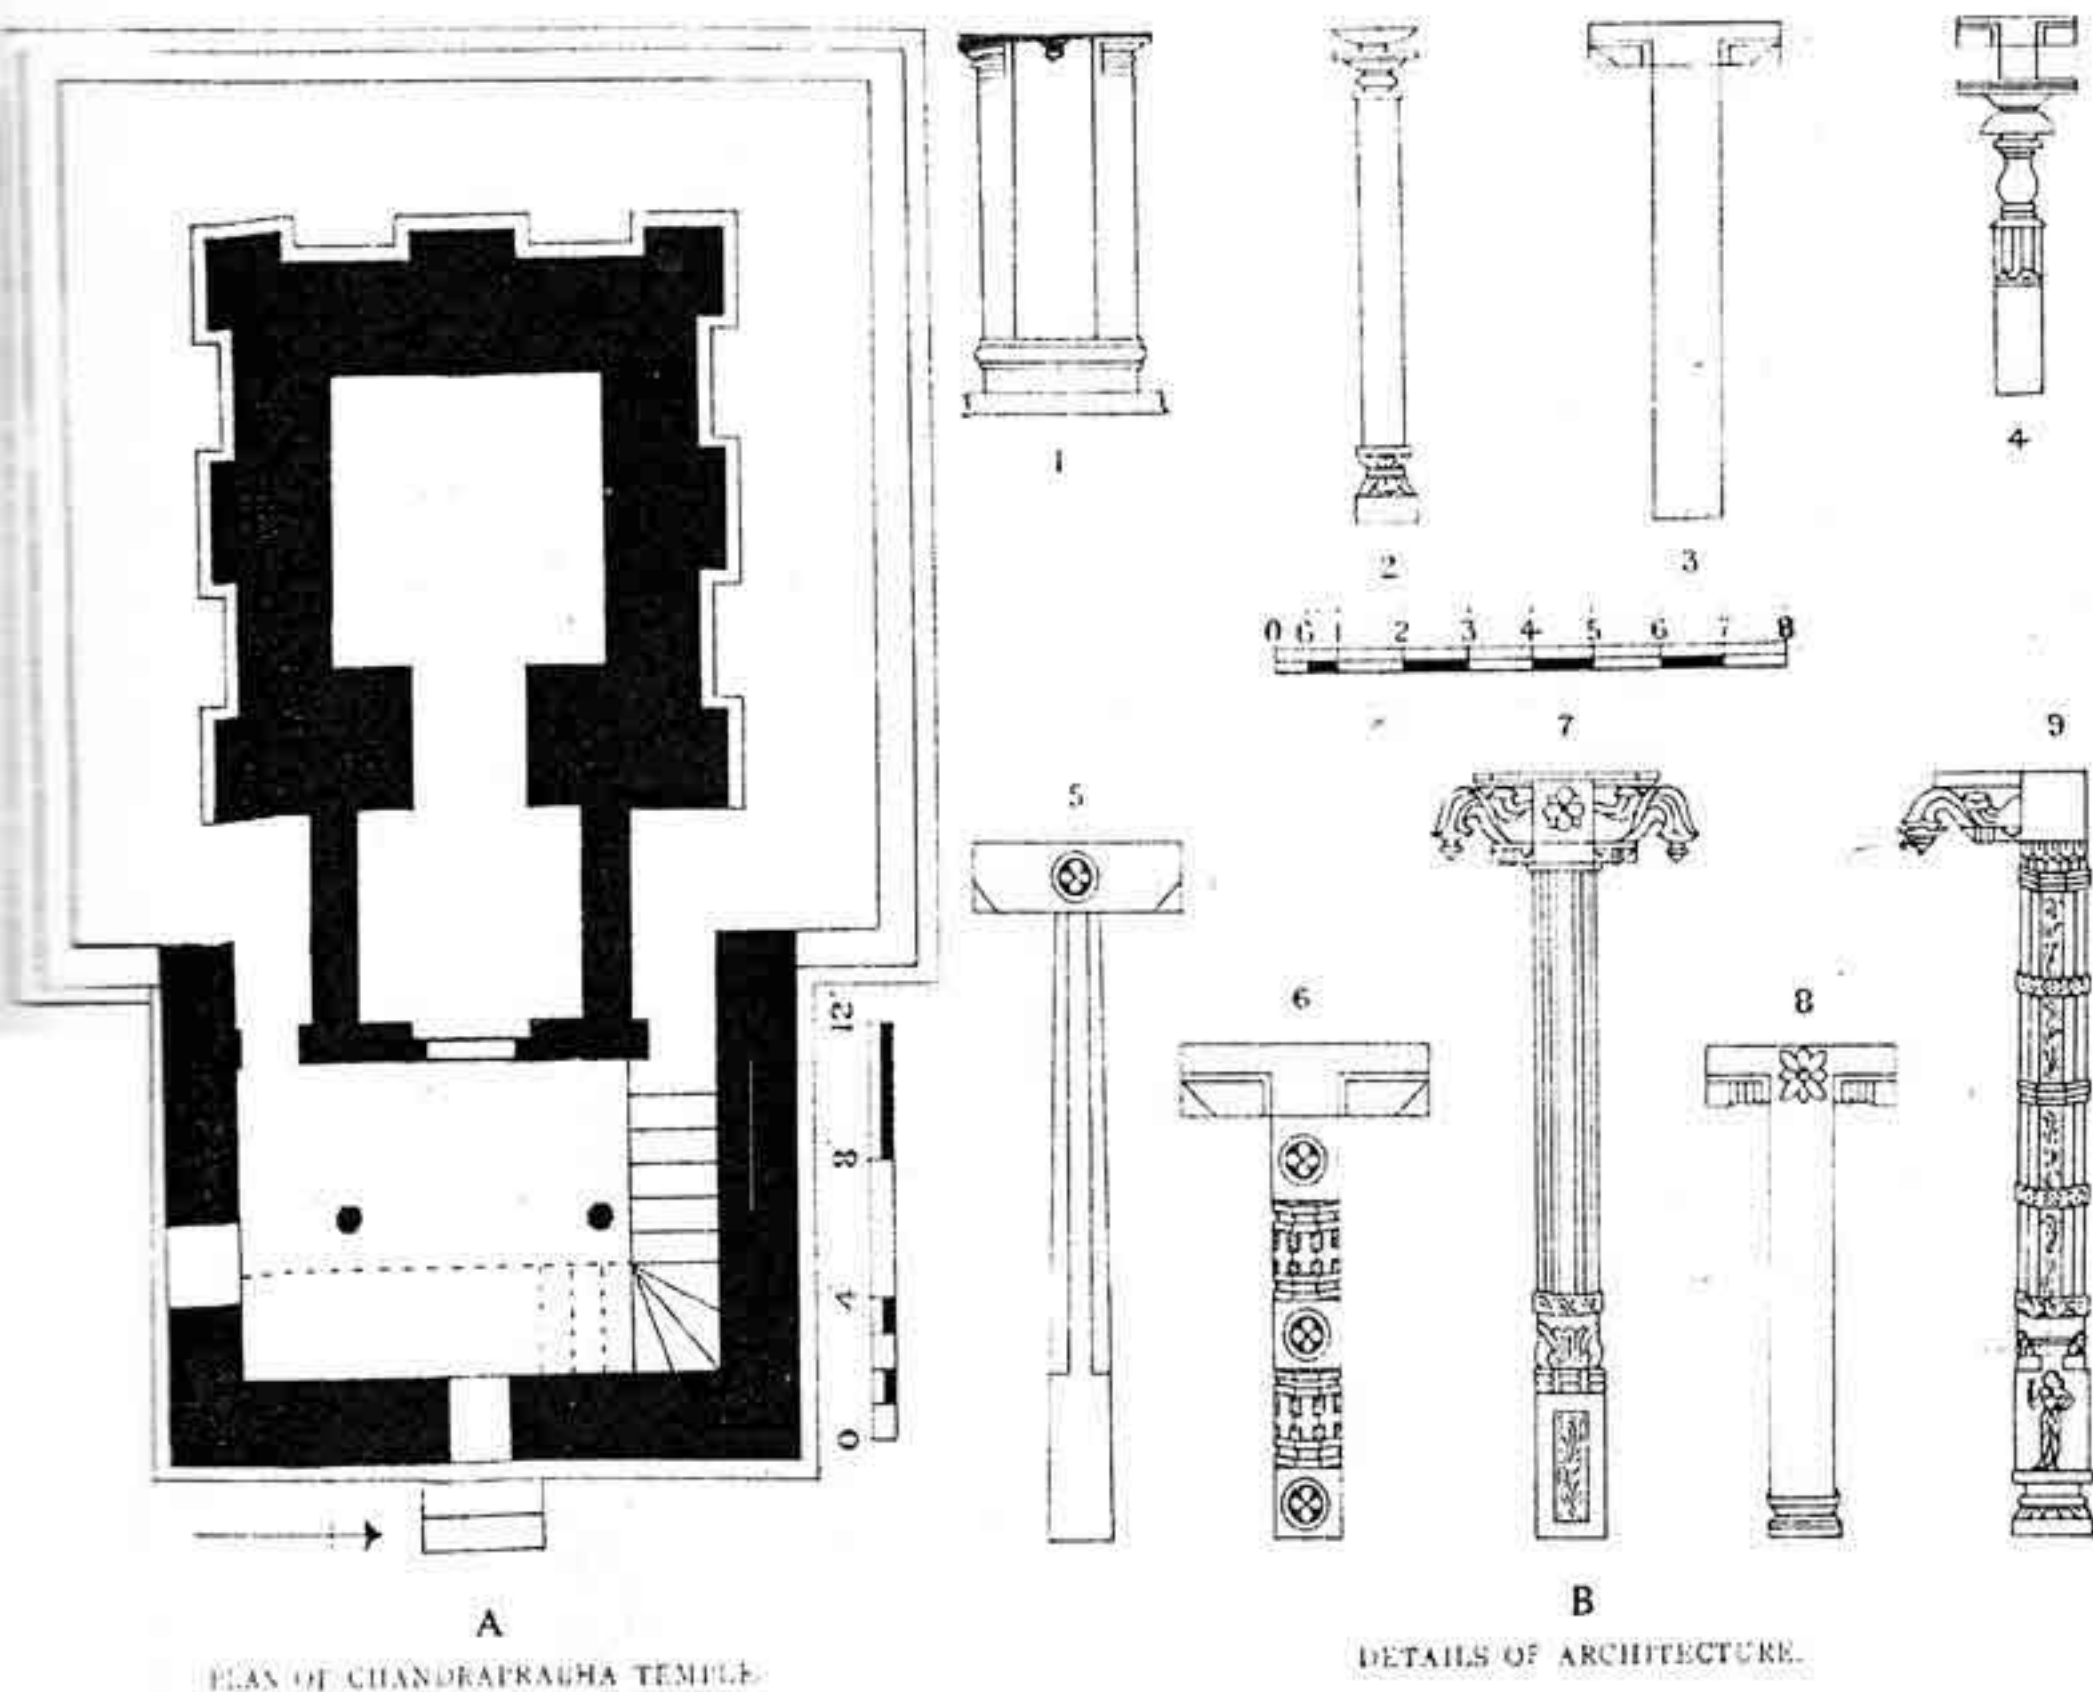
PLATE I.

A. Ground plan of Chandraprabha temple.

The corners of the walls bear pilasters with rearing lions at the bottom. (see - Colour Plate I, fig.1, page no. 31). The corbels above these pilasters, show a curved profile suggesting the extremity of a joist and are ornamented with horizontal mouldings called by Dr. Jouveau Dubreuil "rollers," a motif which is exclusively *Pallava* "very probably borrowed from the art of the carpenter." The niches (*koshtas*) (see - Plate I-B, fig.1, page no. 15) on the walls are simply outlined, not deeply sunk as are those of Chola times. This is also the case with niches found on the walls of the *Vaikuṇṭhanātha* or *Perumāl* temple and the southern wall of the *Matangśvara* temple at Conjeevaram. An interesting feature of the niches both here and in the *Vaikuṇṭhanātha* and *Matangēśvara* temples is that the lintel, which is otherwise plain, has a handle-like projection in its centre pointing downwards and marking the central line of the niche below. The *torana* which we find in the *Pallava* monuments of *Mahendra Varman I.* of *Narasimha Varman I (Māmalla)* at *Mahābalipuram* and later on in monuments of the *Chola* period such as the *Thajavur* and *Chidambaram* temple is absent here. This is strange, especially when we remember that this type of niche has to be placed, in point of time, between the niches of the *Mahendra-Māmalla* and early *Chola* epochs. So when we are expecting to find in the later *Pallava* niches *toranas* of more ornate and developed form leading into the early *Chola* type, it is surprising to find here that they have disappeared. No explanation for this sudden disappearance is readily available; but the similar absence of this feature in the *Vaikuṇṭhanātha* temple suggests that the two are likely to date from about the same period. As the construction of the *Vaikuṇṭhanātha* temple is established on epigraphical grounds to fall within the reign of the later *Pallava* King *Paramēśvara Varman II*, the son and successor of *Rājasimha* to whom the *Kailāsanātha* temple is attributed, we may safely assign the *Chandraprabha* temple also to this period.

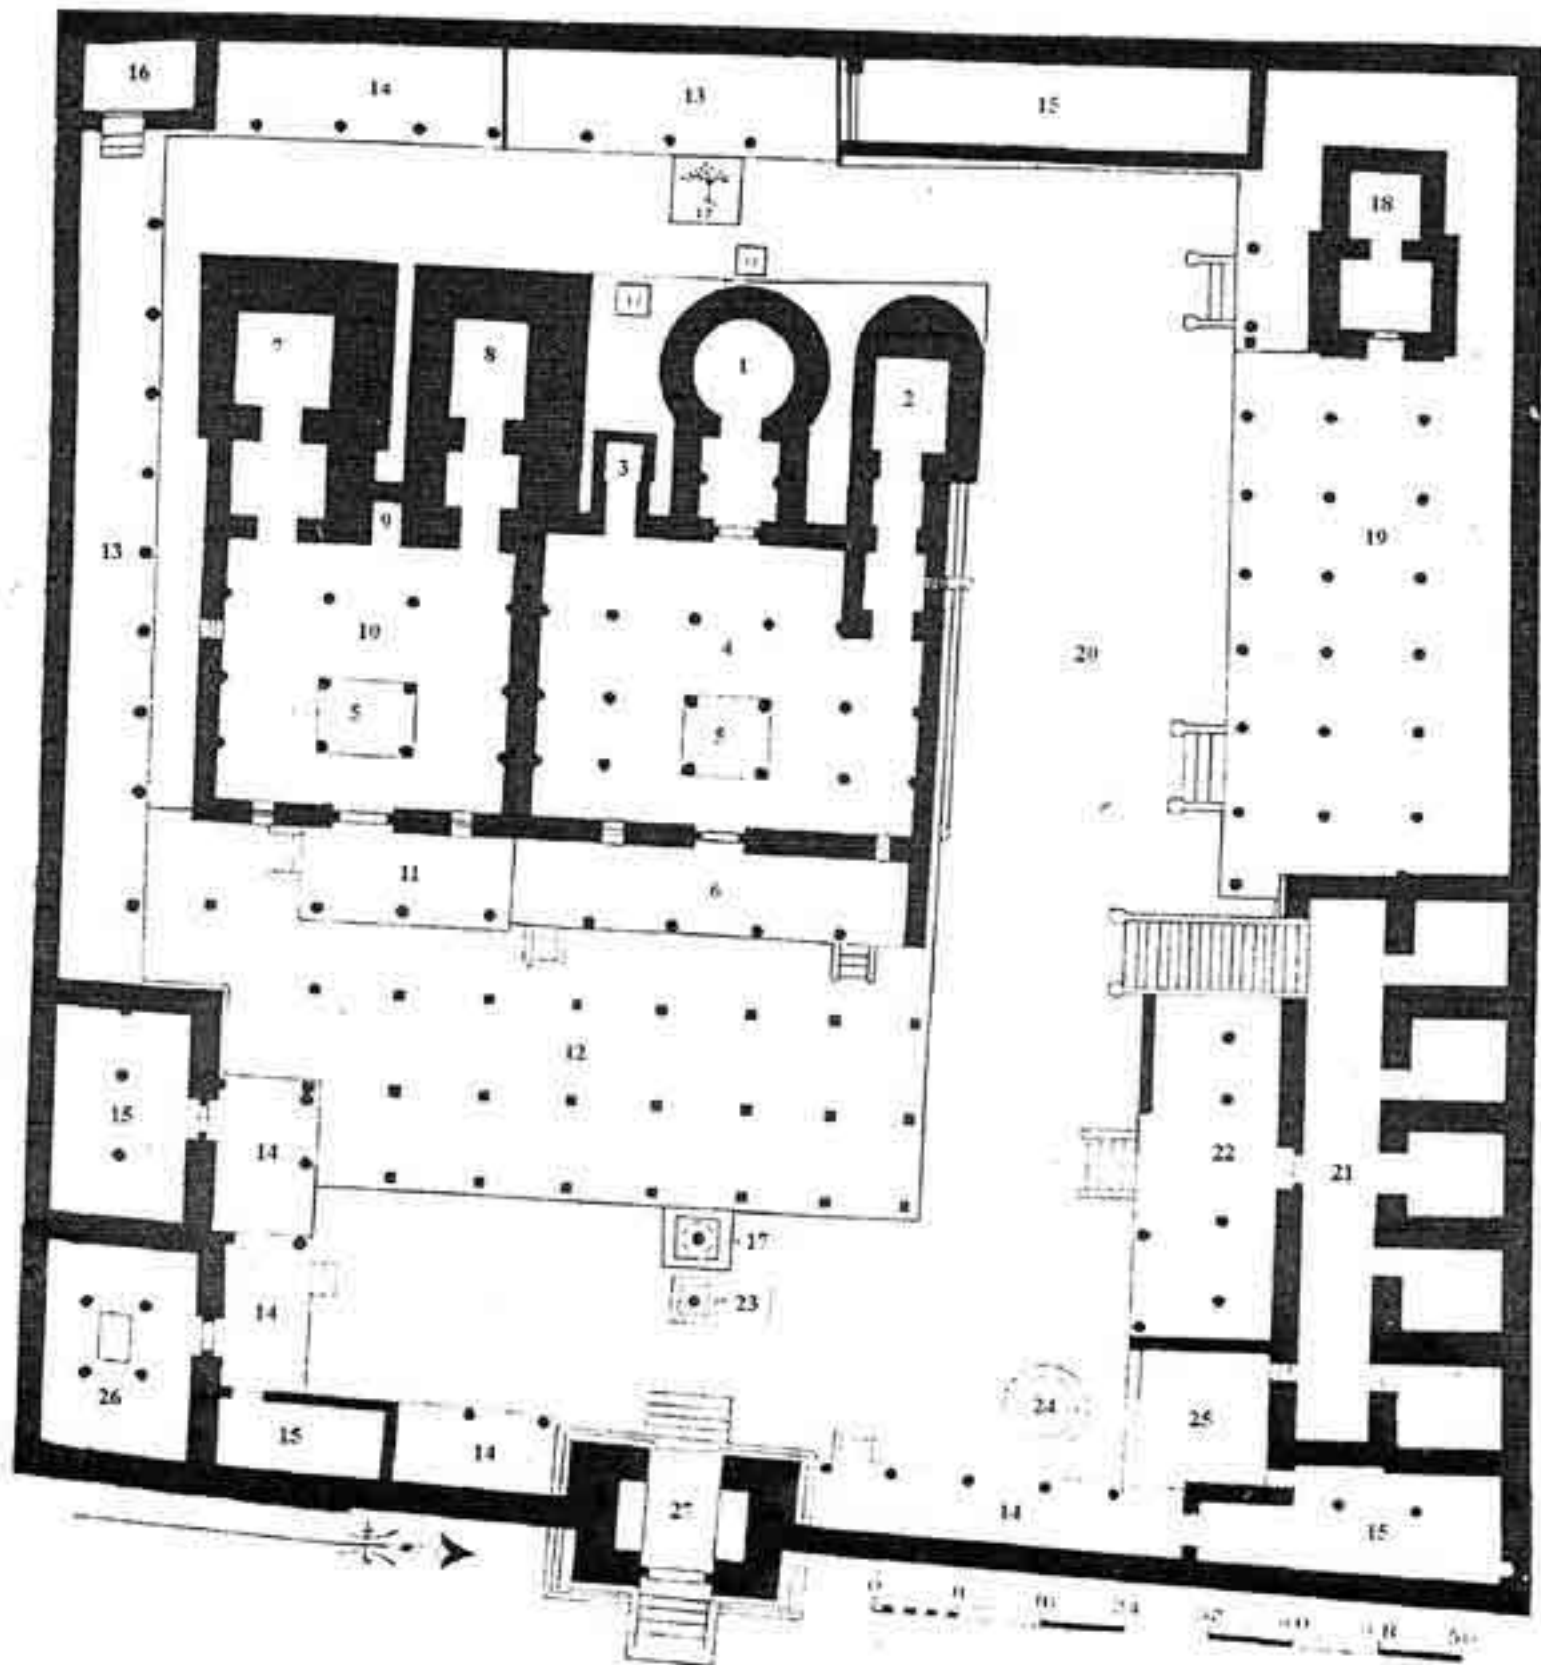
PLATE II.

PLAN OF VARDHAMĀNA TEMPLE

Thus it would appear that there was an opening on the west wall of the *Ardha maṇḍapa* in front of the present shrine of *Vardhamāna*. The shrines of *Vardhamāna* and *Pushpadanta* are both apsidal, that of *Pushpadanta* (see - Plate II, 2) being smaller than that of *Vardhamāna*. As proof of frequent interference with these shrines till very recently by way of repairs, it may be noted that a little part of the southern wall of the brick shrine of *Pushpadanta* is built of irregular granite pieces loosely laid.

The shrine dedicated to *Dharmadevī*, the *Yakshī* of *Neminaātha* (see - Plate II, 3), is situated to the south of the *Vardhamāna* shrine and is totally different from the other two shrines in that it is very small and square instead of being apsidal. According to local traditions the image of *Dharmadevī* appears to have been introduced into the temple, according to one version, in the thirteenth century A.D. from the *Kāmākshī* temple at Conjeevaram, and according to another in the ninth century A.D., soon after *Śaṅkarāchārya* established the *Kāmakoṭi-pīṭha* in the *Kāmākshī* temple, both versions regard *Kāmākshī* temple as having originally been a Jaina shrine dedicated to *Dharmadevī*, the *Yakshī* of *Neminaātha*. The veracity of these two versions is much disputable as the traditions themselves are of late origin, probably two centuries old. These traditions clearly suggest that the image of *Dharmadevī* was a late acquisition to the *Vardhamāna* temple. It is of brick. It has been jointed to the *Vardhamāna-Ardha maṇḍapa* by making a very narrow opening in its west wall.

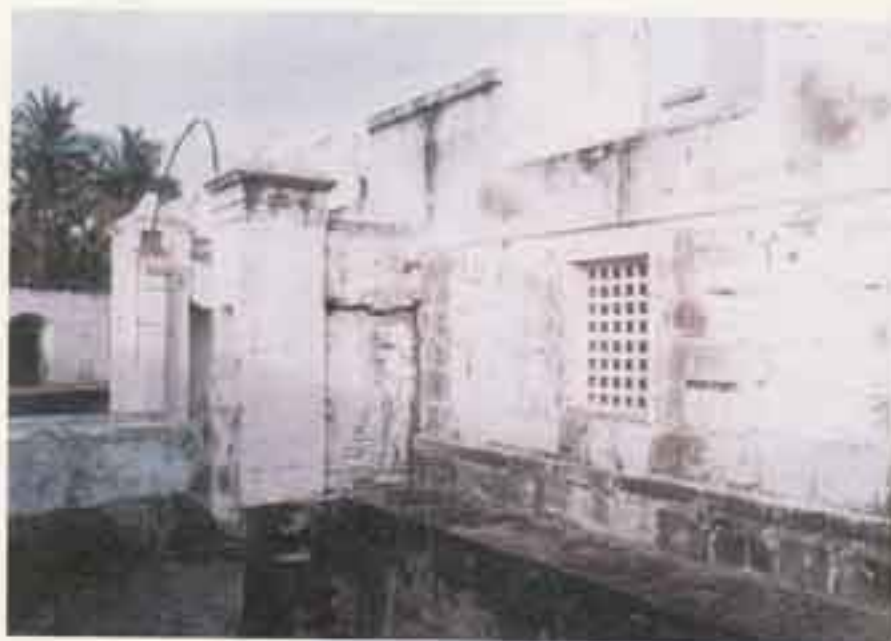
Manora - Before conservation - crack is seen

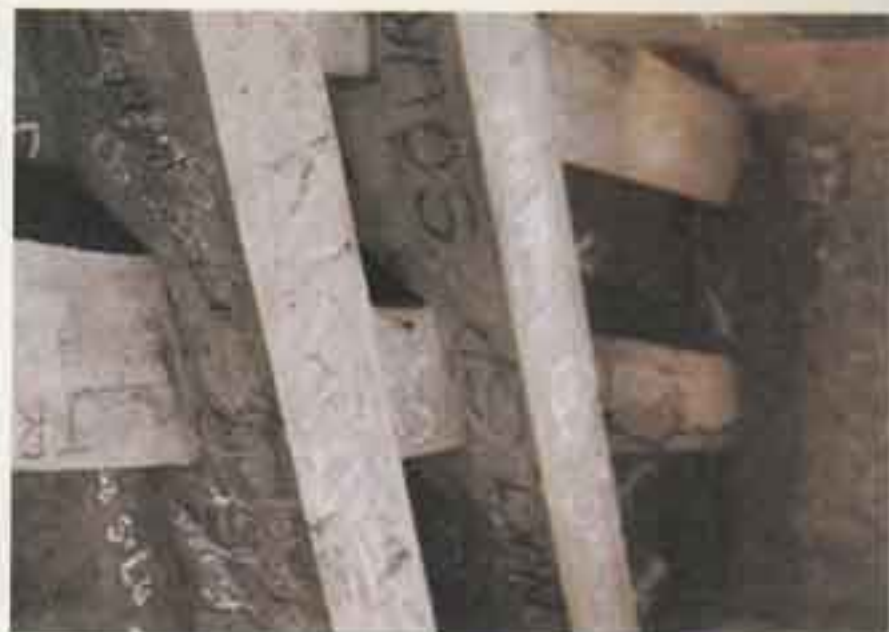
RCC roof support given for Manora resulting in cracks

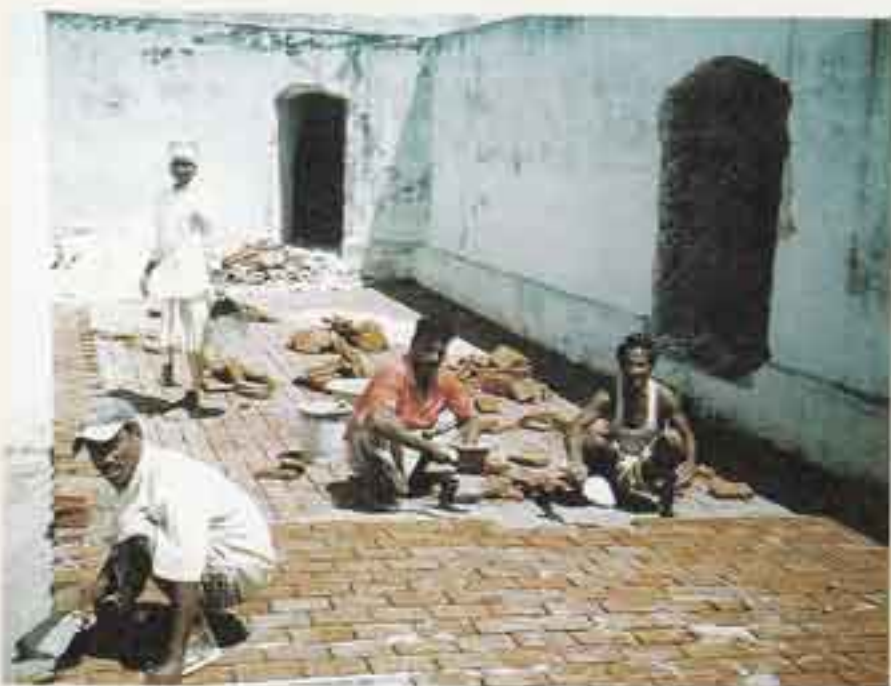
Laying special type of brick floor tiles at Manora

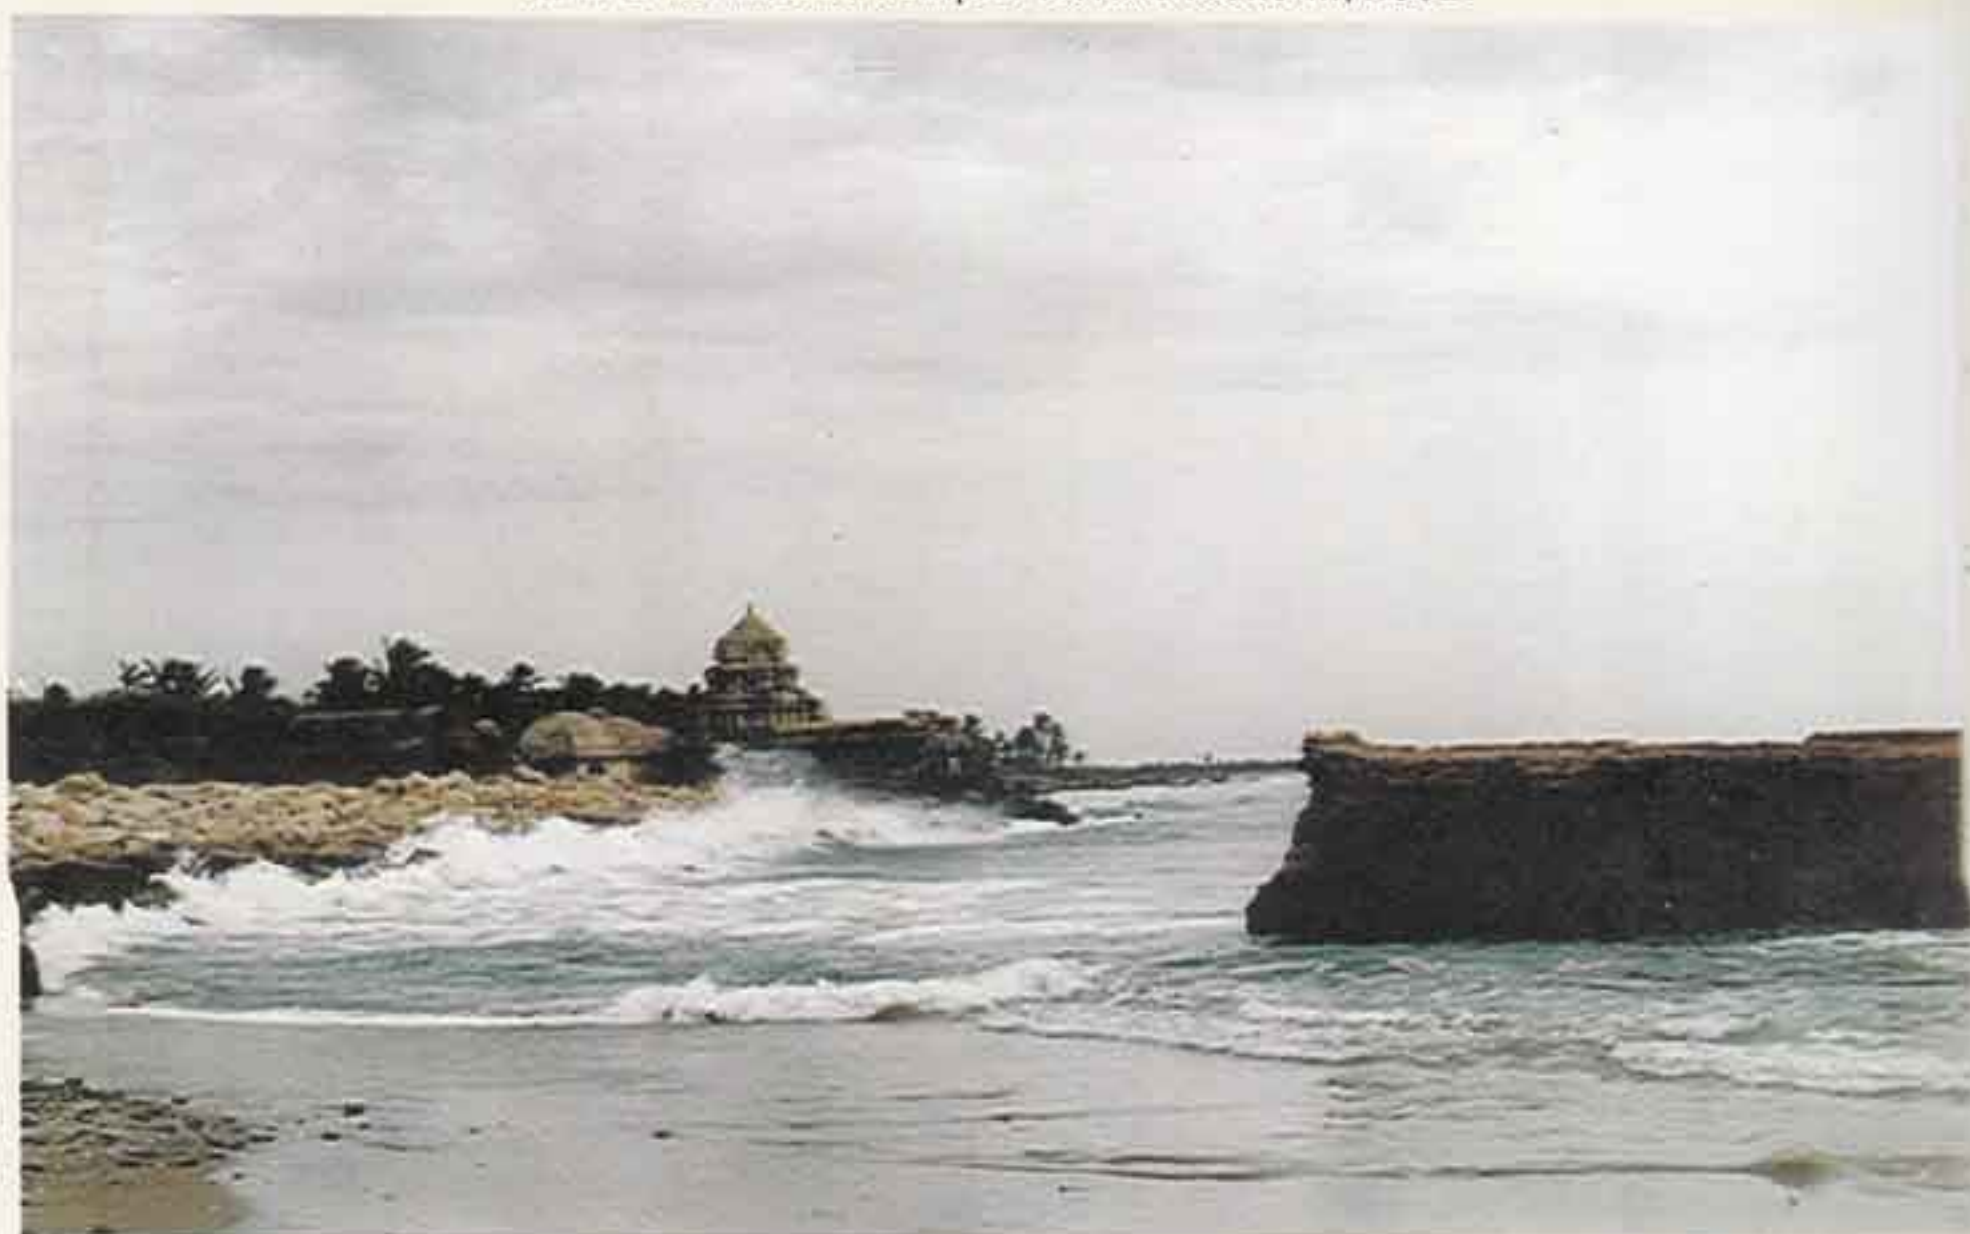
Masilamaninathar temple on the shore of Bay of Bengal at Tranquebar - After Tsunami, 2004

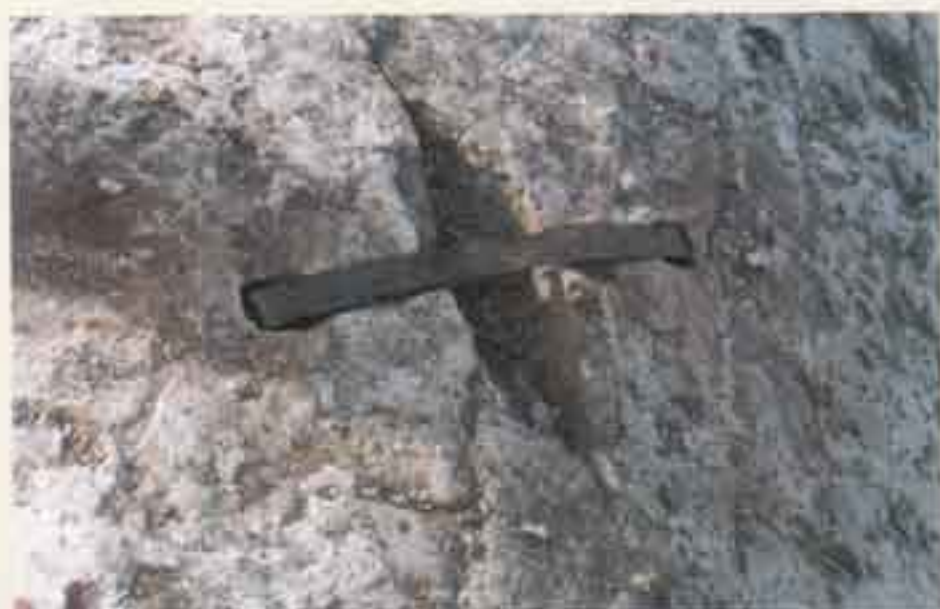
Crack mending method with Copper plate

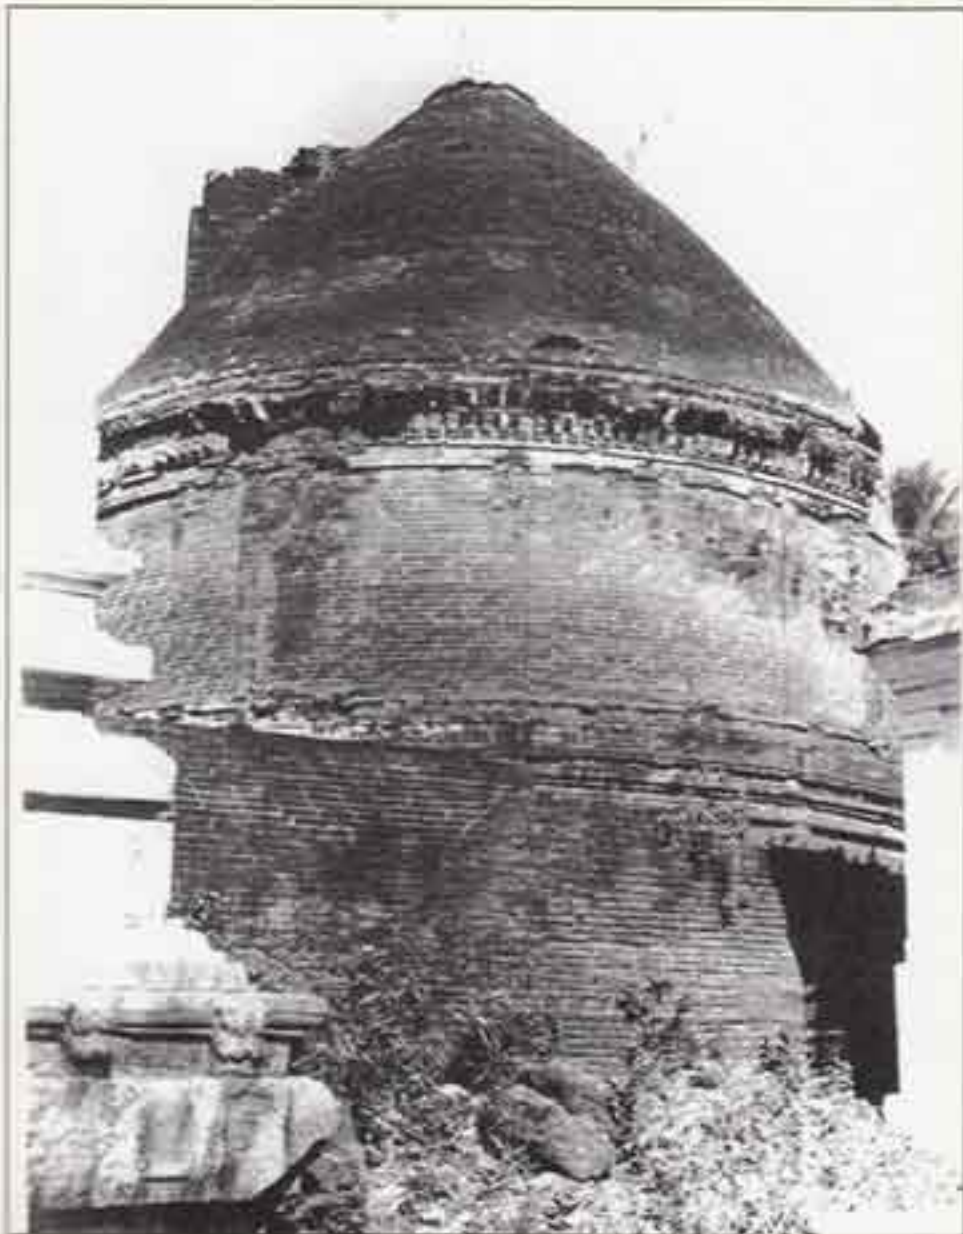
Dilapidated condition of the *Tirupalaithurai* granary

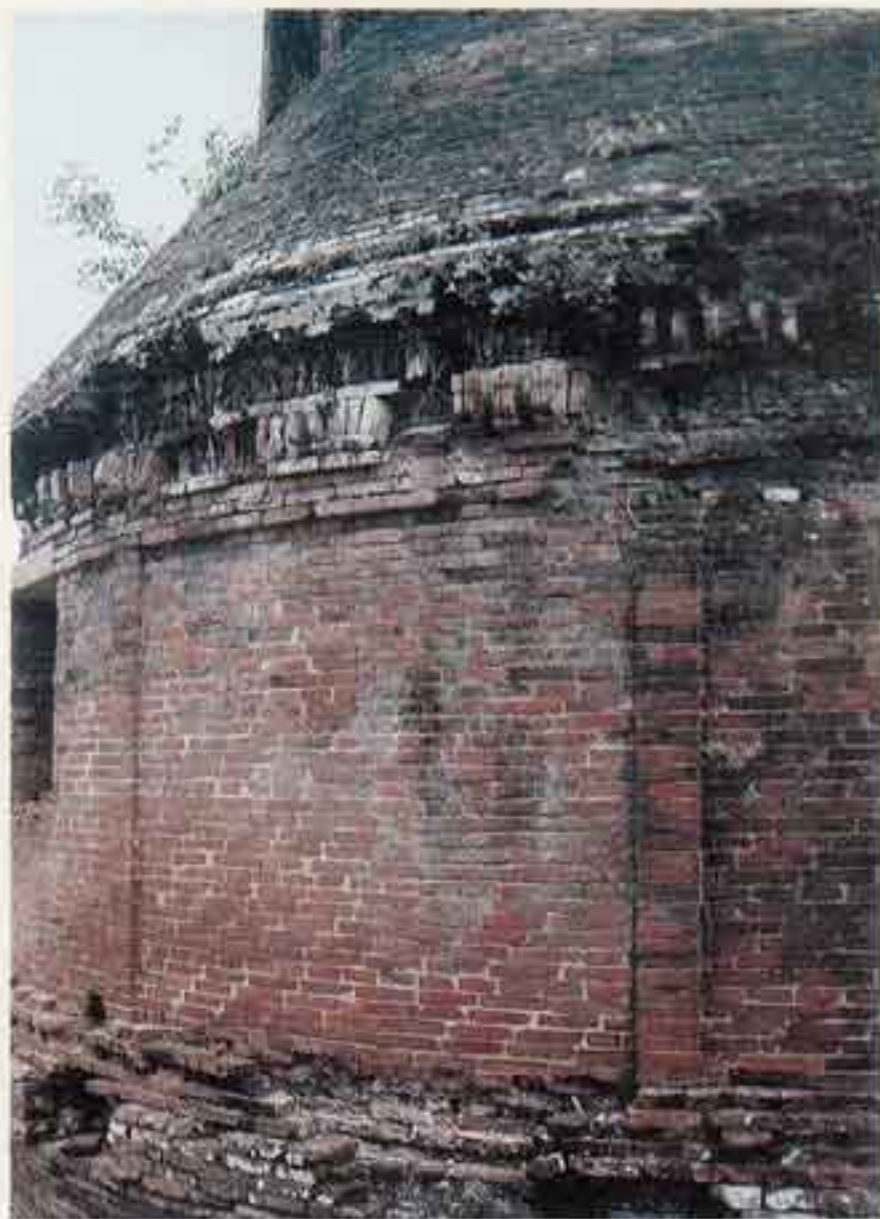
Damaged portions of the granary in closer view

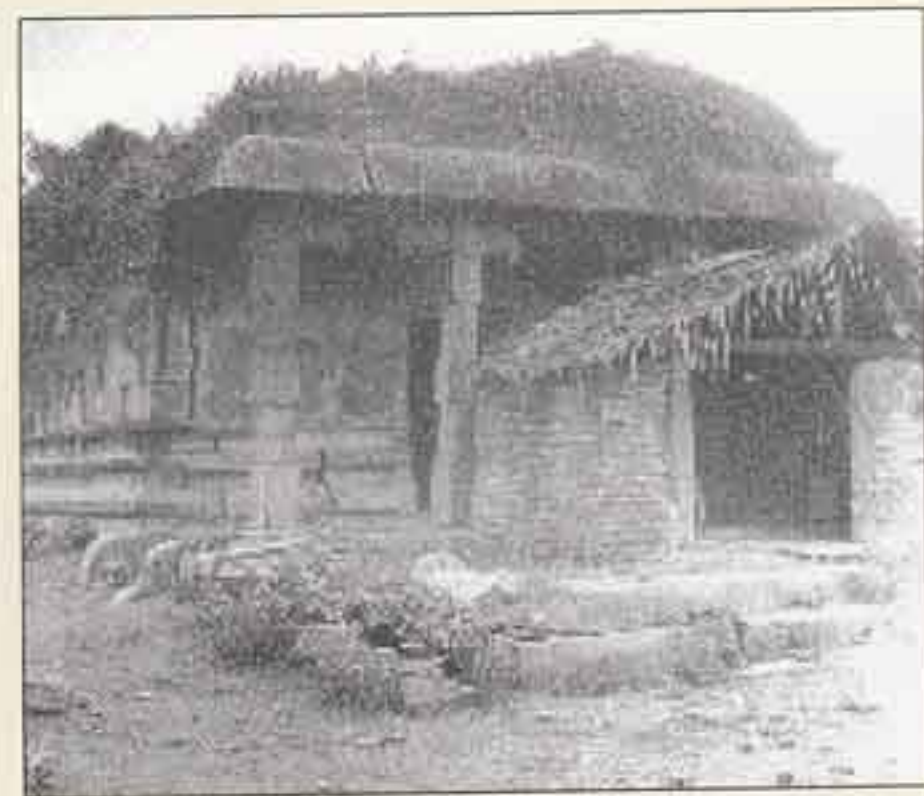
Vittalapuram -1980s damaged Mukha Mandapa

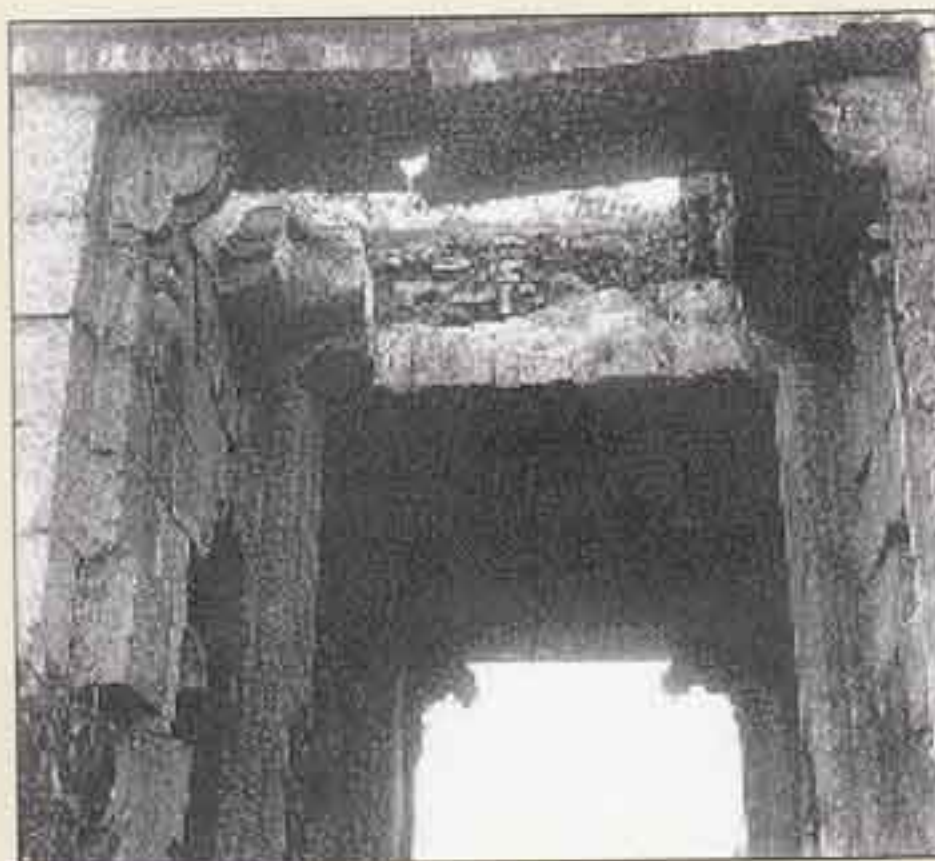
Vittalapuram 1980s - The Mahadwara damaged

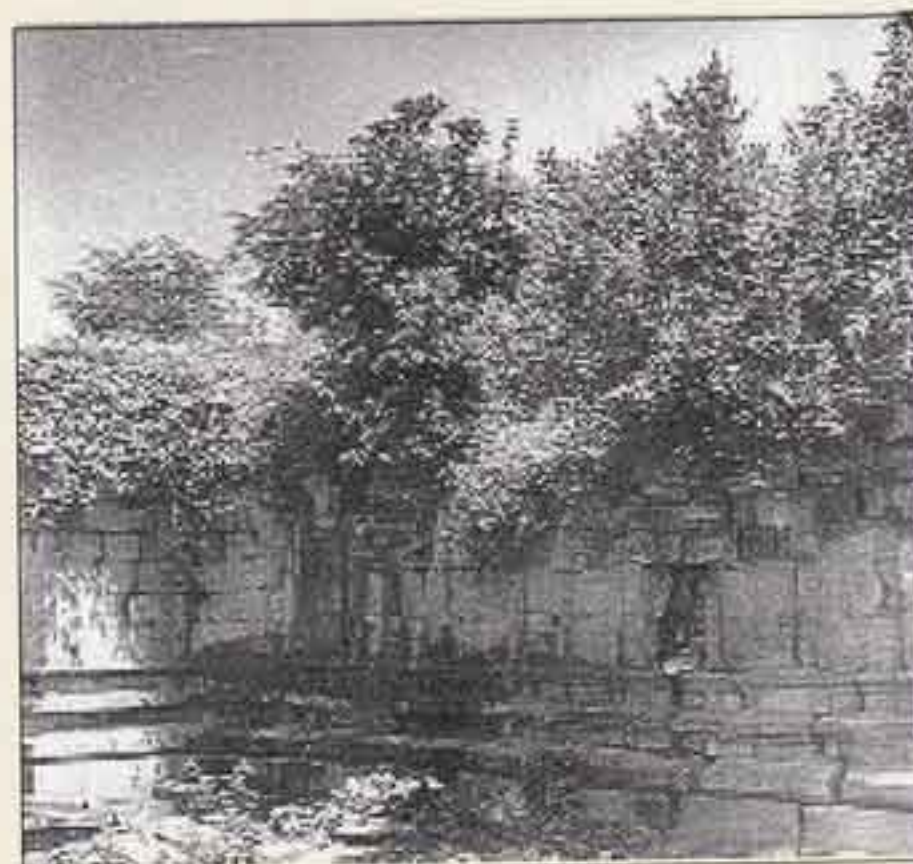
Vittalapuram 1980s with tree growth on main shrine

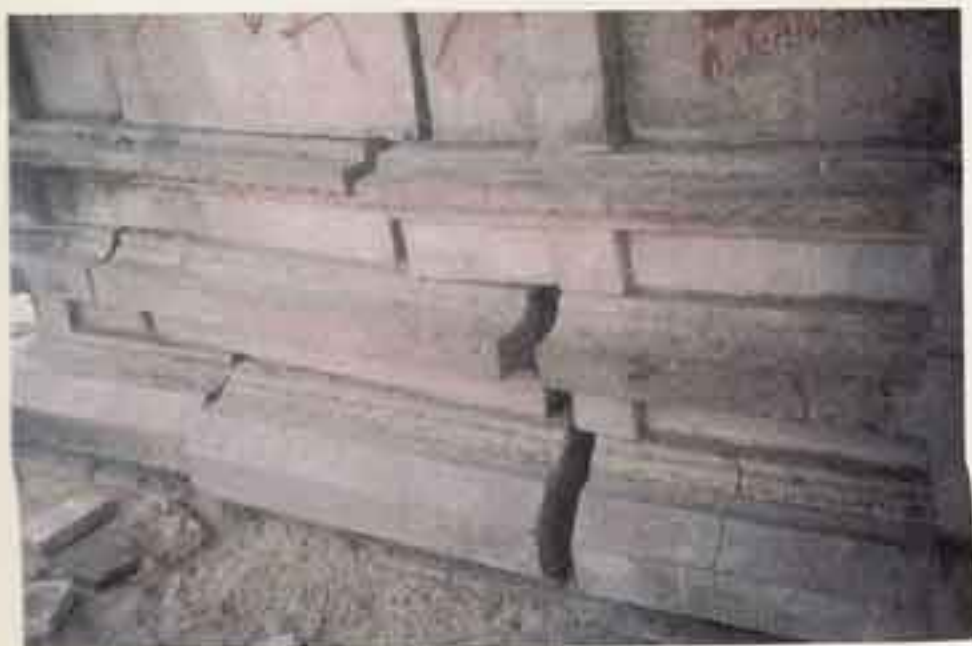
Damaged Upa Peetah

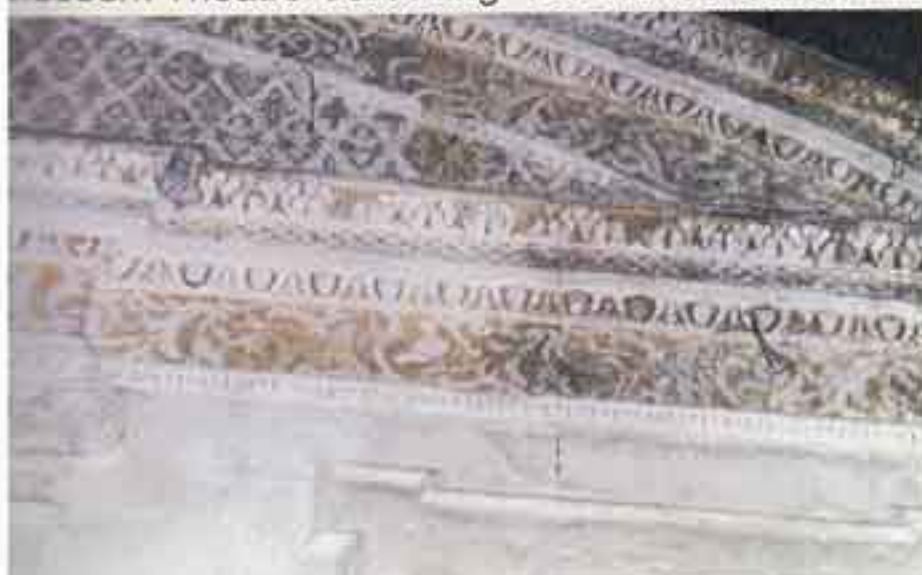
Museum Theatre - Damaged Cornice work - Before

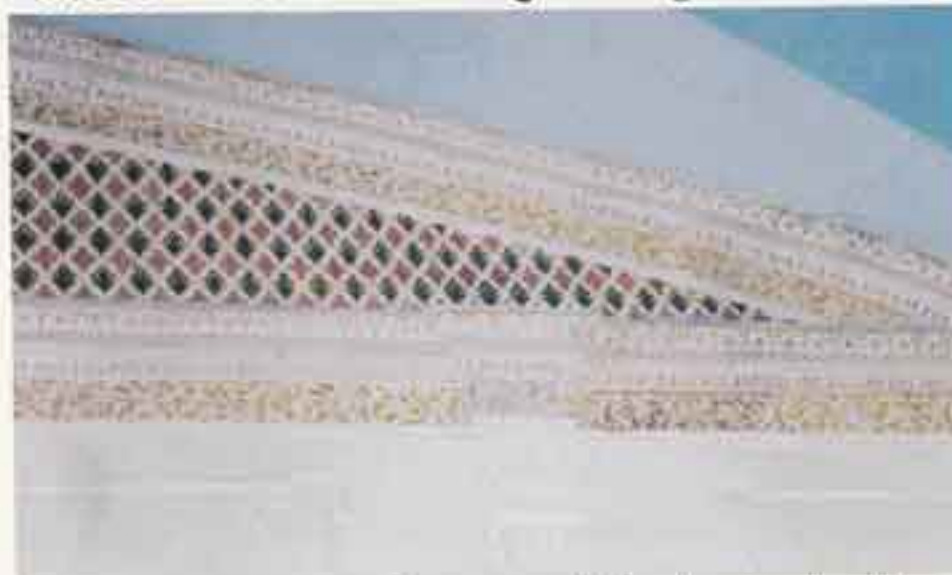
Museum Theatre - Conserved Cornice work - After

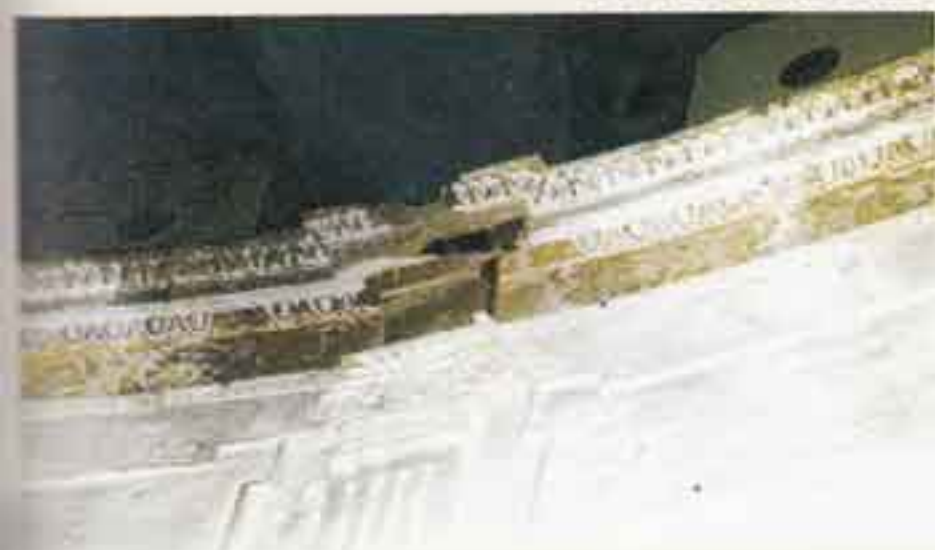
Museum Theatre - Damaged Cornice
- Before conservation

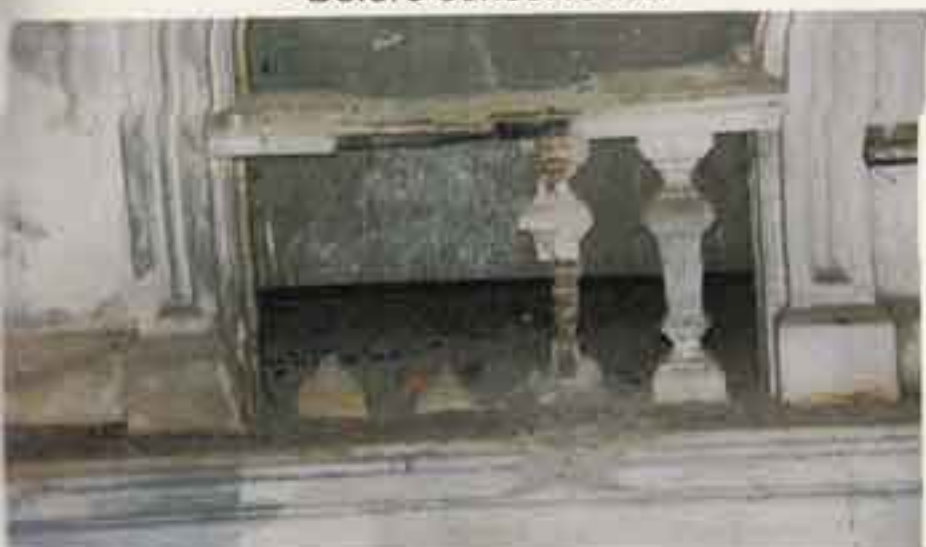
Damaged portion of Museum Theatre

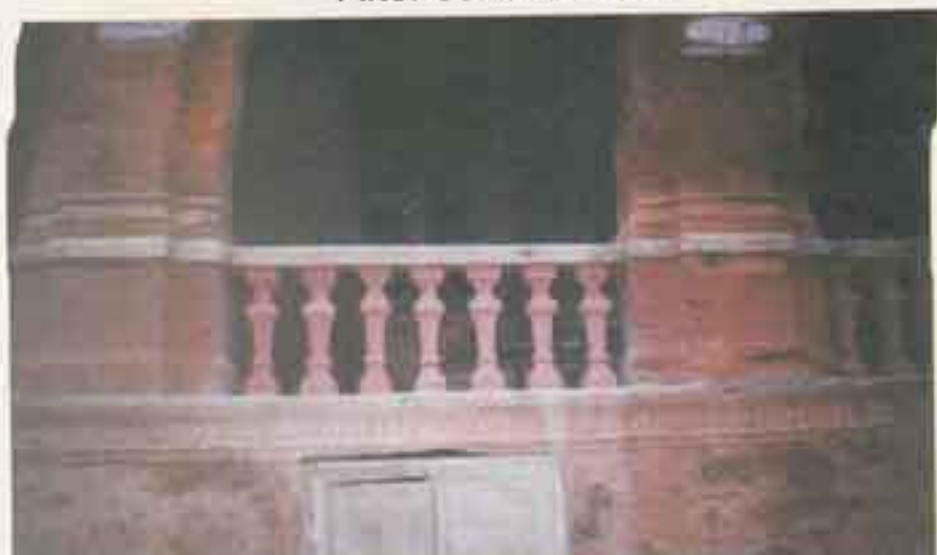
Conserved portion of Museum Theatre

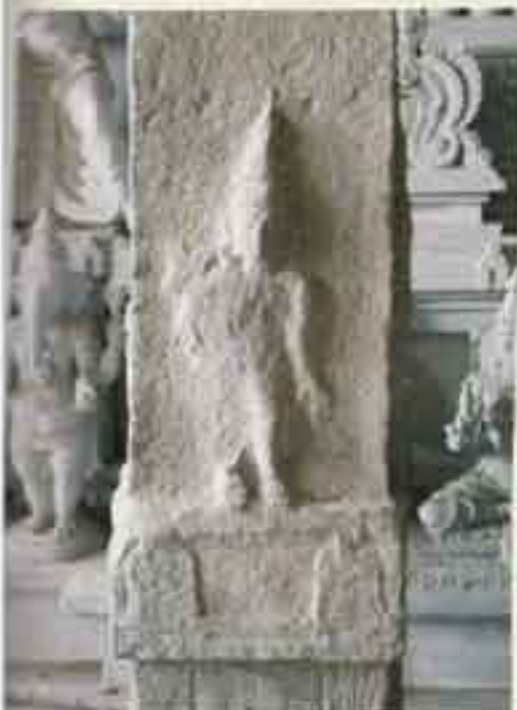
Bad effects of sand blasting, which has resulted in a crack in the bottom part of a pillar near the *Ramana Cave* temple mended by application of cement in the Thousand Pillared *mandapa* of the *Arunachaleswarar* Temple at *Tiruvannamalai*.

Bas relief sculpture badly damaged near the *Ramana Cave* temple in the Thousand Pillared *mandapa*

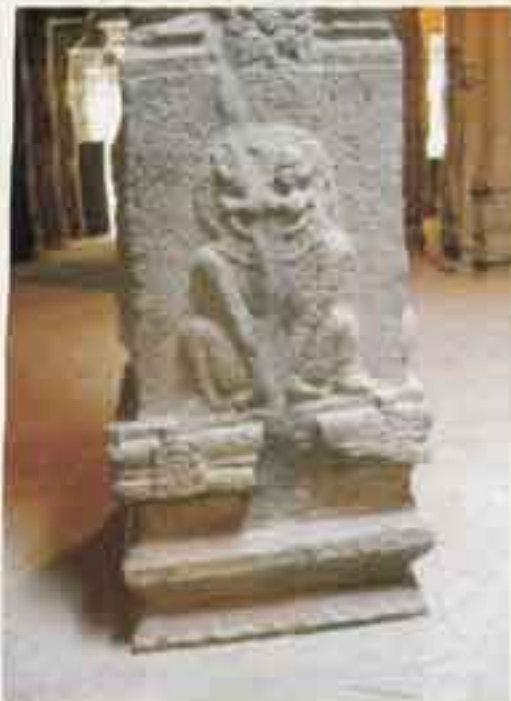
Another instance of damage in the Thousand Pillared *Mandapa* of *Tiruvannamalai* Temple.

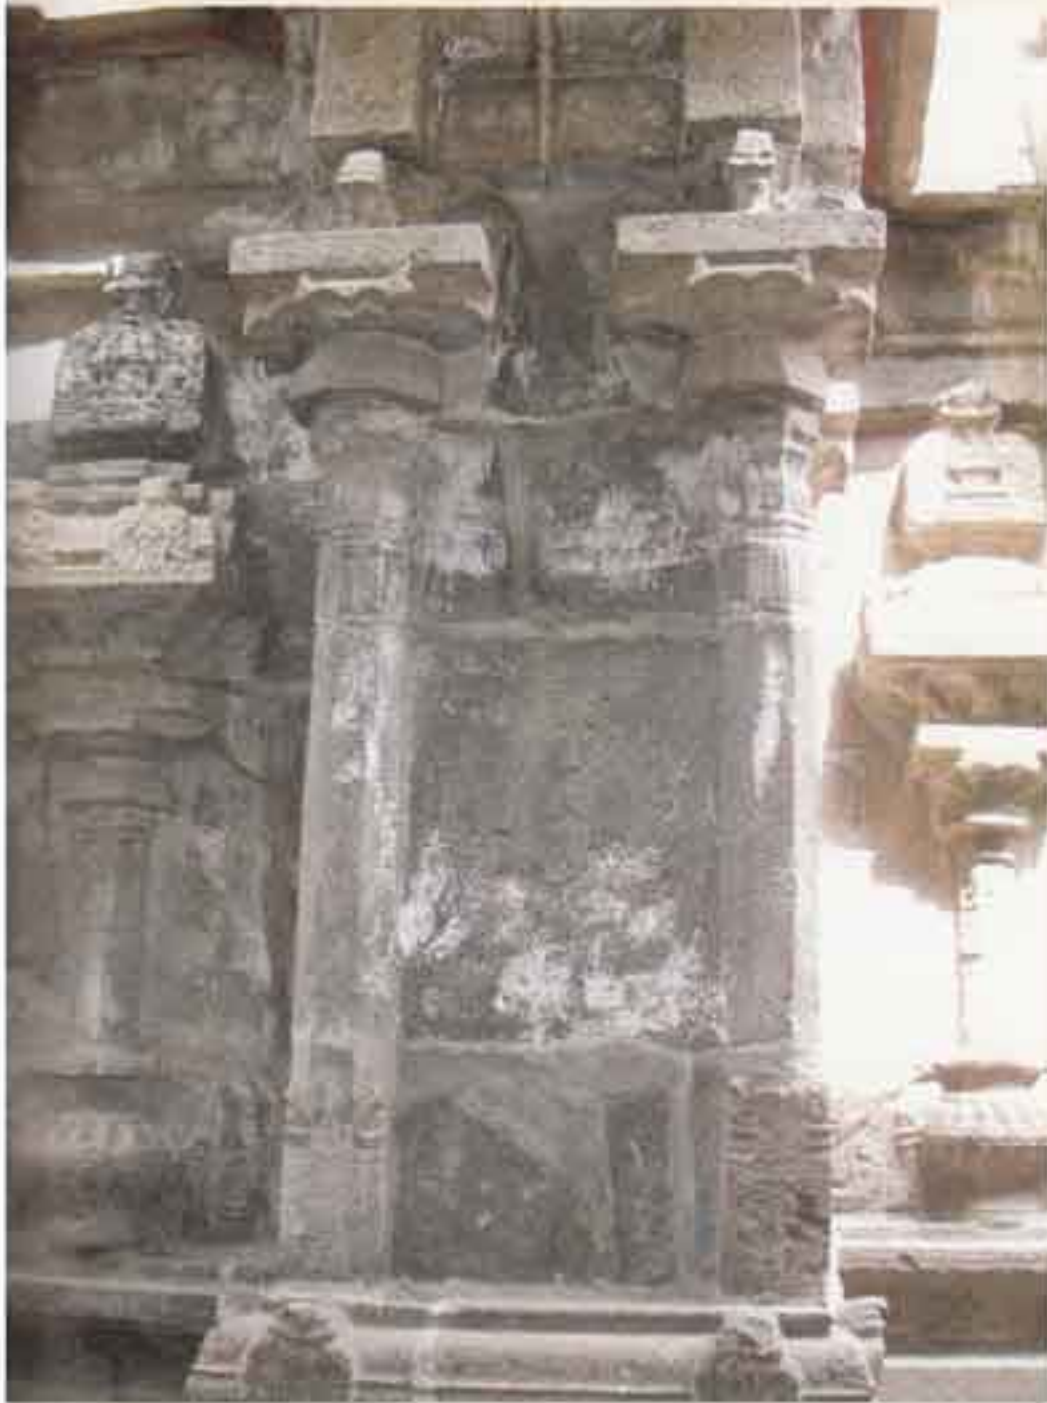
Sand blasting damage to granite stone walls in a *Vaishnavite* Temple, Chennai mended with cement

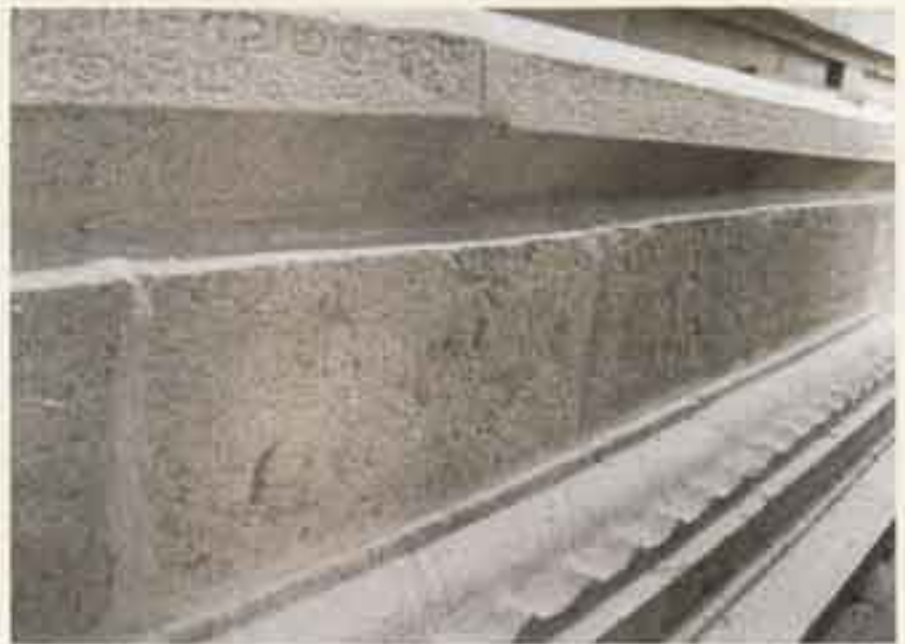
Damage by Sand blasting - defacing of stone inscriptions at a *Vaishnavite* Temple, Chennai
