MANUAL ON CONSERVATION AND RESTORATION OF MONUMENTS

Proceedings of an Administrator turned
Conservation Archaeologist cum Museologist

DR. R. K. SINGH

2007

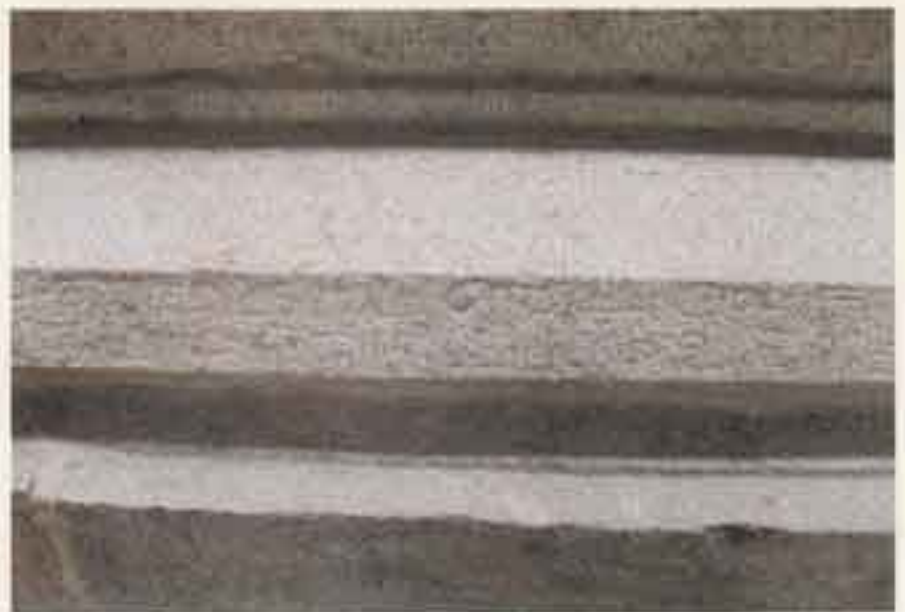
Damage by Sand blasting - defacing of stone inscriptions at a *Vaishnavite* Temple, Chennai - another example

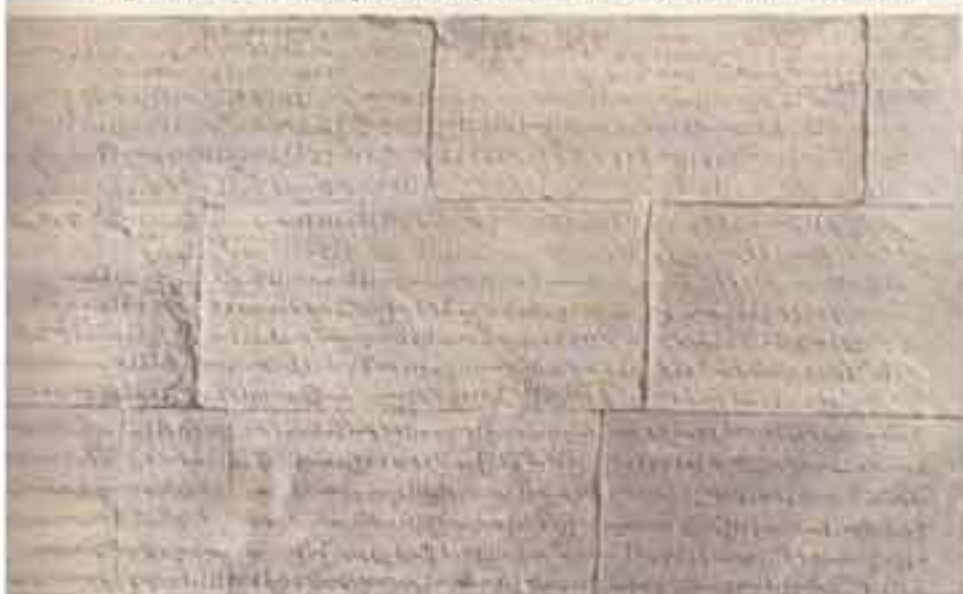
Sand blasting- inscription partially defaced

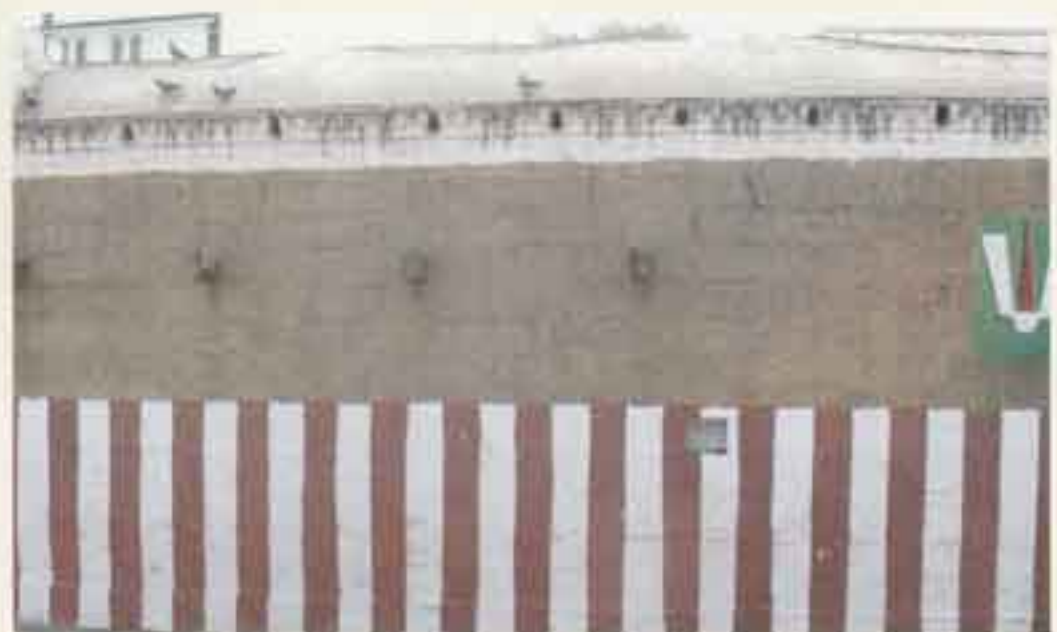
Chemically treated wall of *Vaishnavite* Temple, Chennai in good condition in 2007 - 4 years later

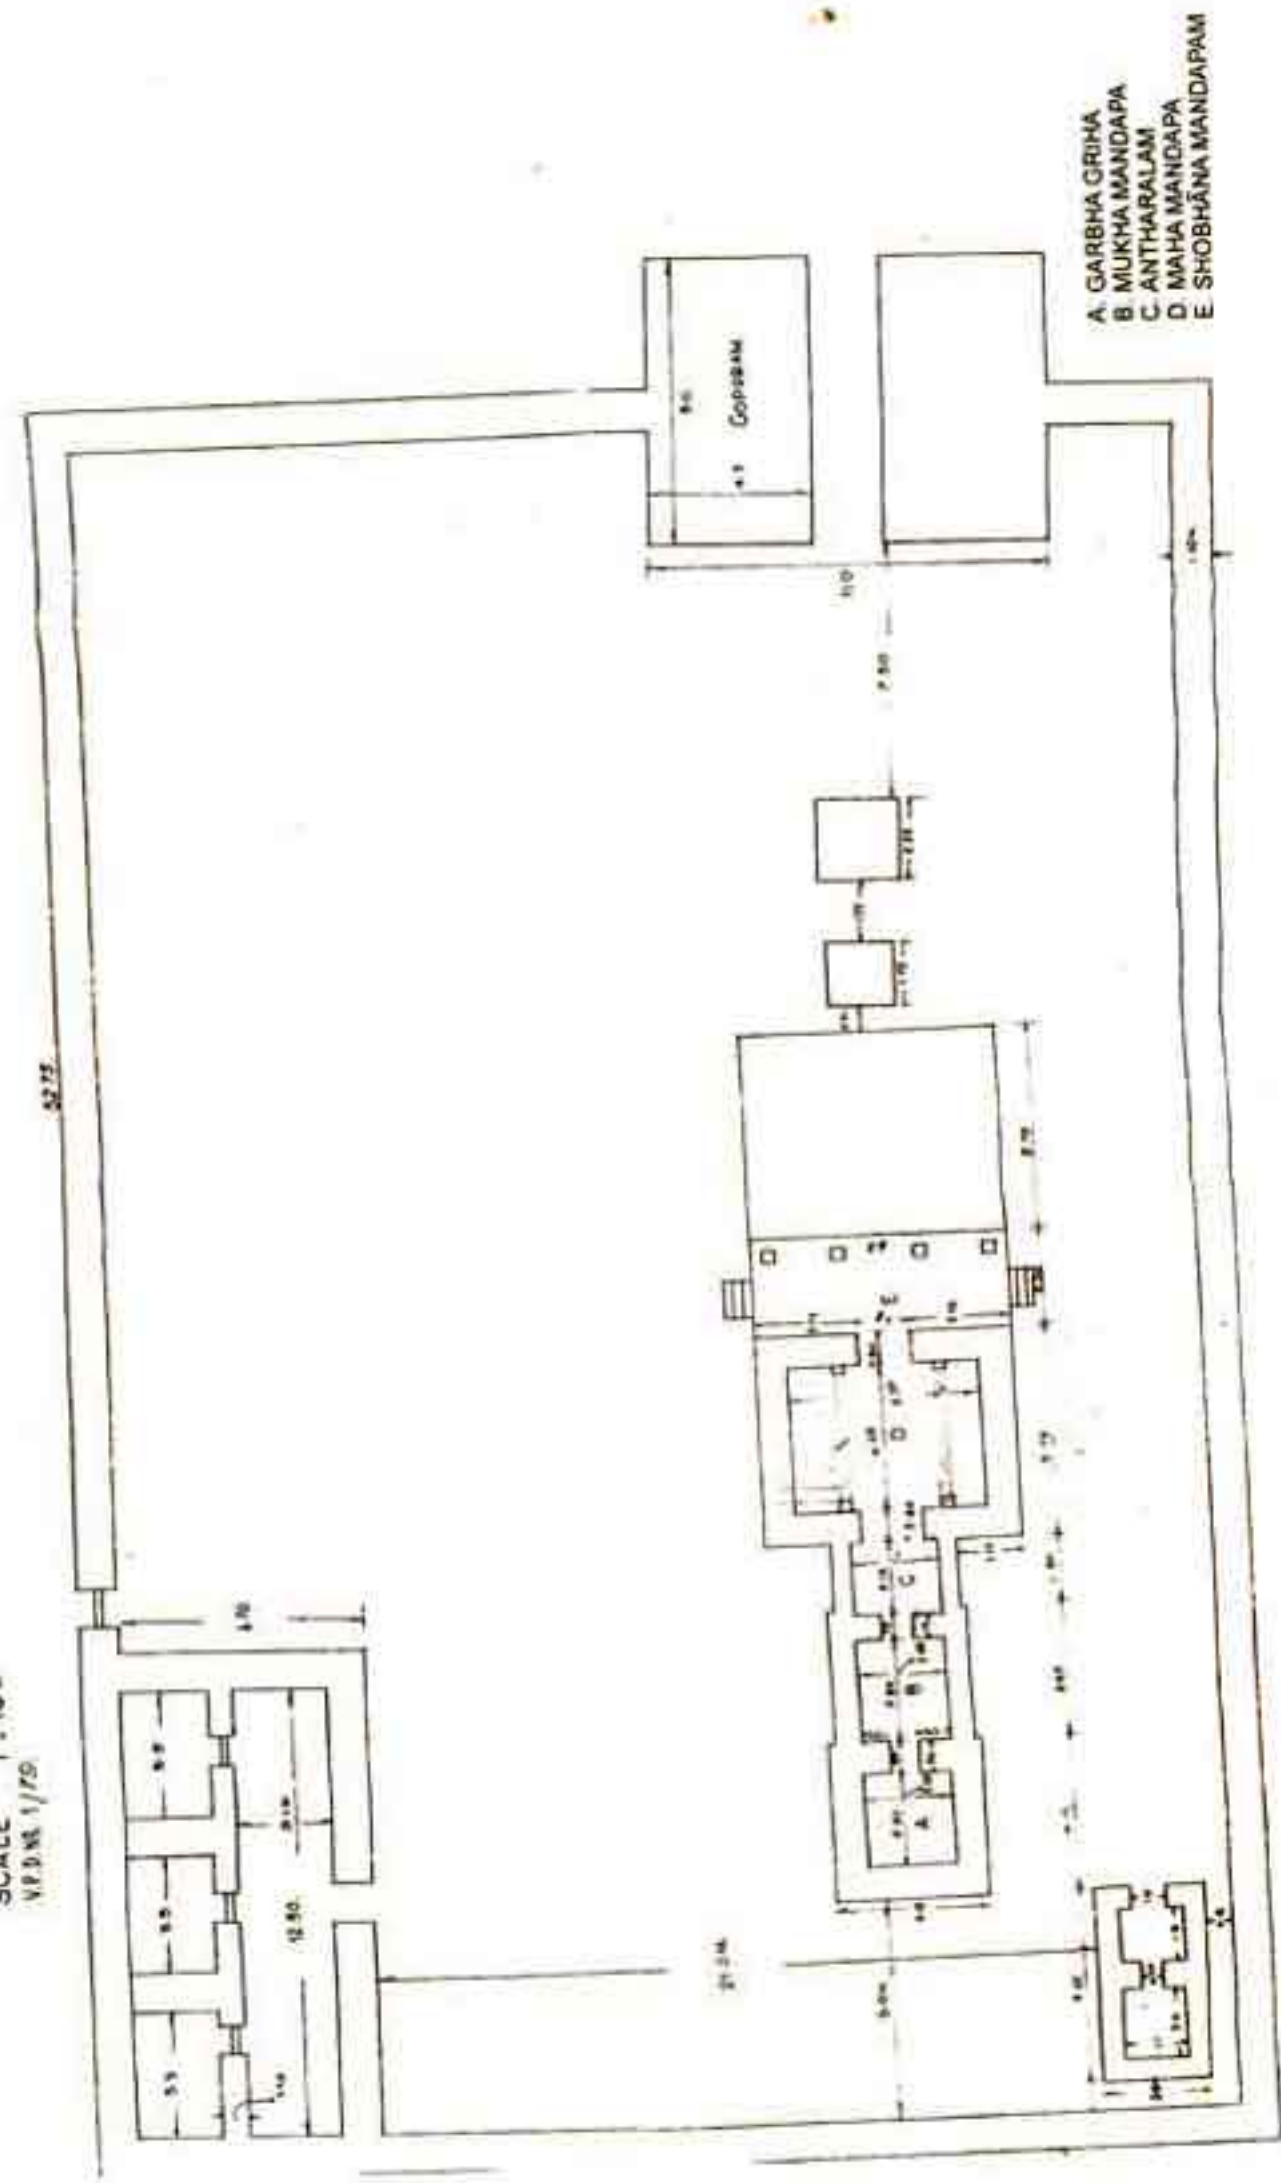
Vittala Temple (Vitalapuram) Ground Plan

- A. GARBHA GRHA
- B. MUKHA MANDAPA
- C. ANTHARALAM
- D. MAHA MANDAPA
- E. SHOBHANA MANDAPAM
